CORRESPONDENCE/MEMORANDUM

SUBJECT: Concerns for the safety of staff at the Racine Air Monitoring Site.

Racine Air Monitoring Site

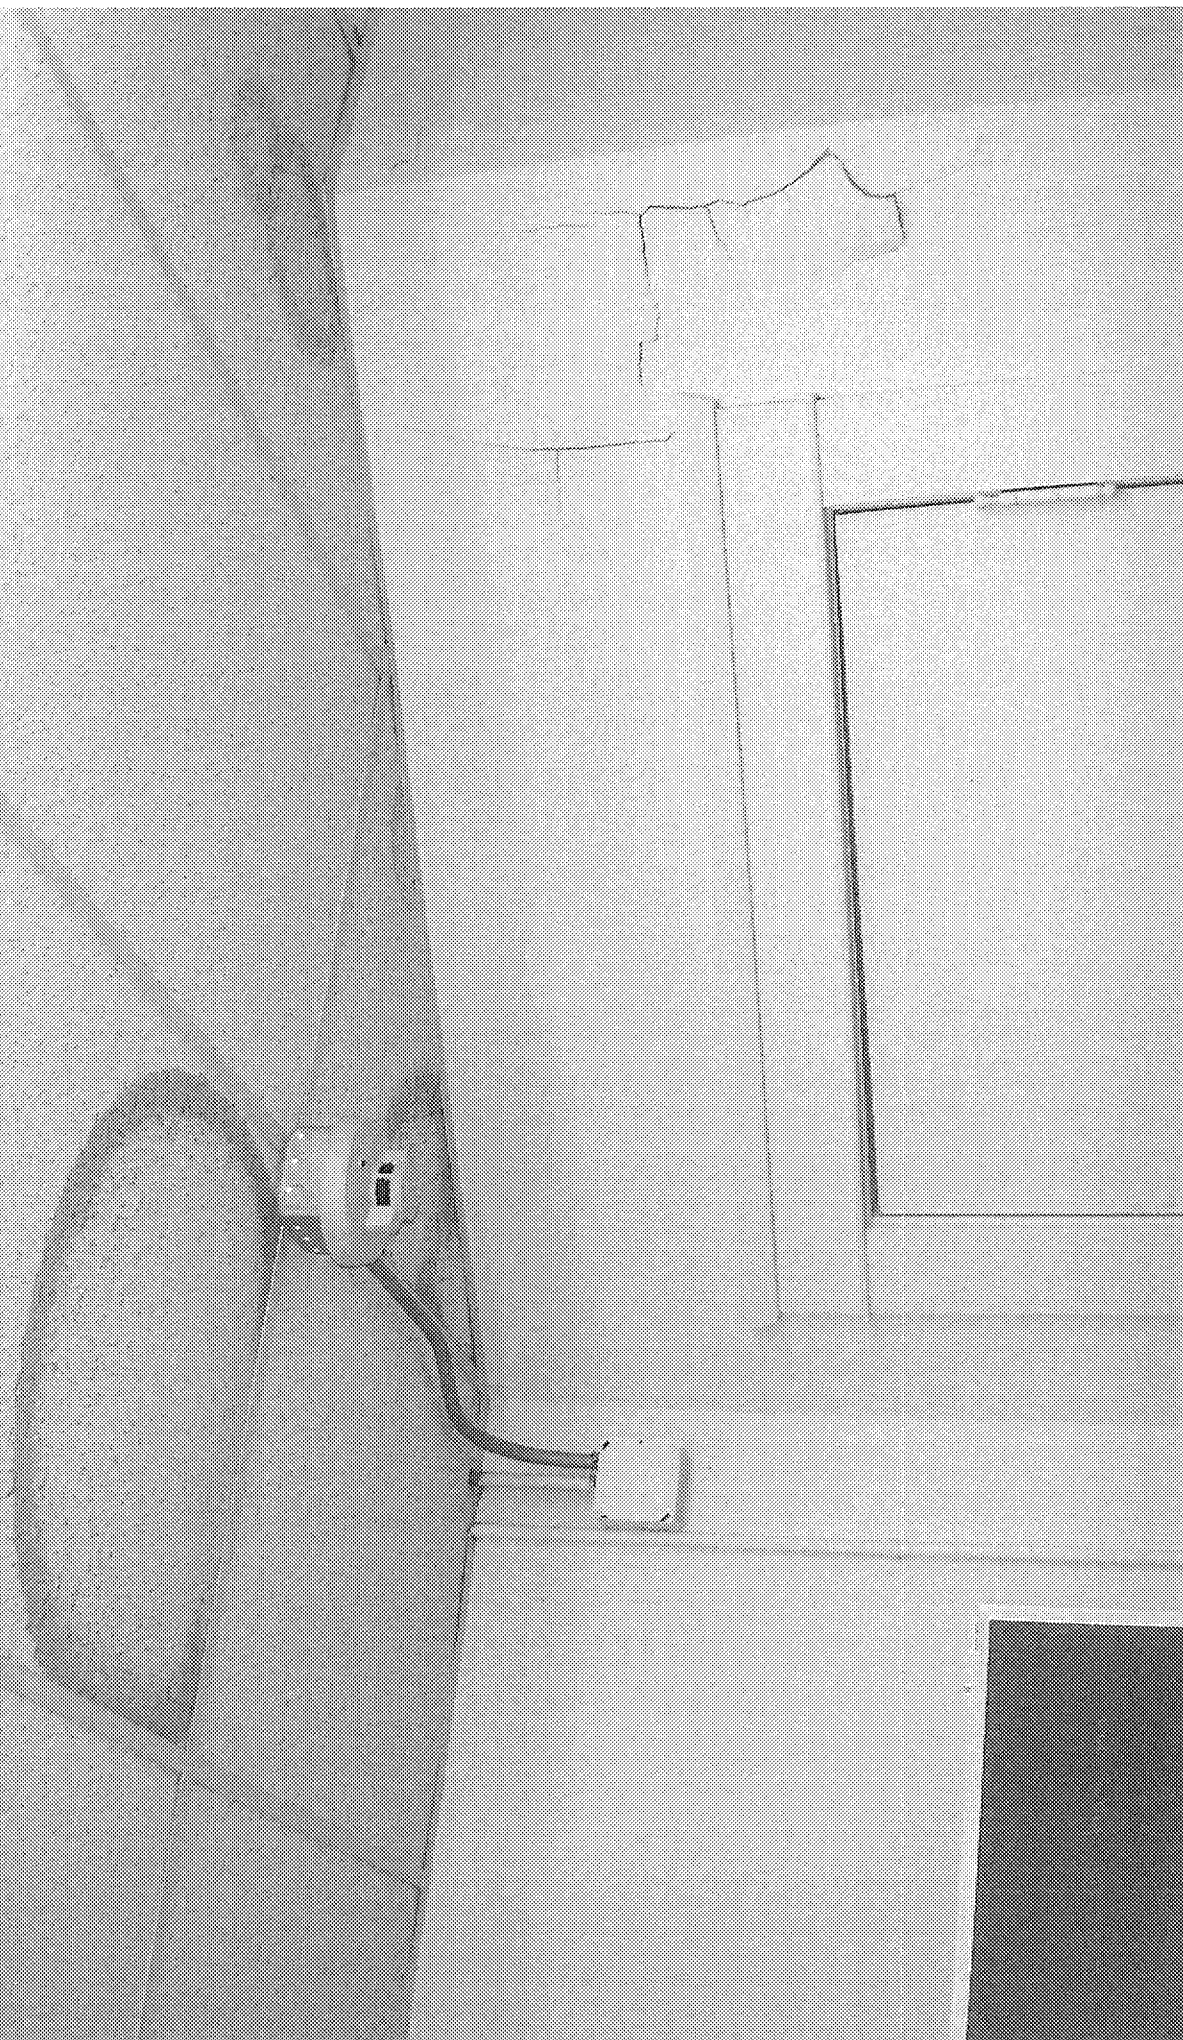
Within the office space used there are instances of multiple water leaks with damage highly visible. Some of the water leakage has occurred near or next to sources of electricity. Any wiring exposed to water should be inspected by the owner of the building to ensure its integrity and guard against fire which could prove fatal to anyone caught in the building. The water damage which is visible, has not been repaired, calls into question the structural integrity of the building especially the roof where some of the equipment resides. (See CFR 1926.501(a)(2) below). There are numerous holes in the plaster and sagging ceiling tiles.

Expanded look at ceiling
leaks over entrance
door. Note the leak over
the detector that is
hardwired to the
electrical system.

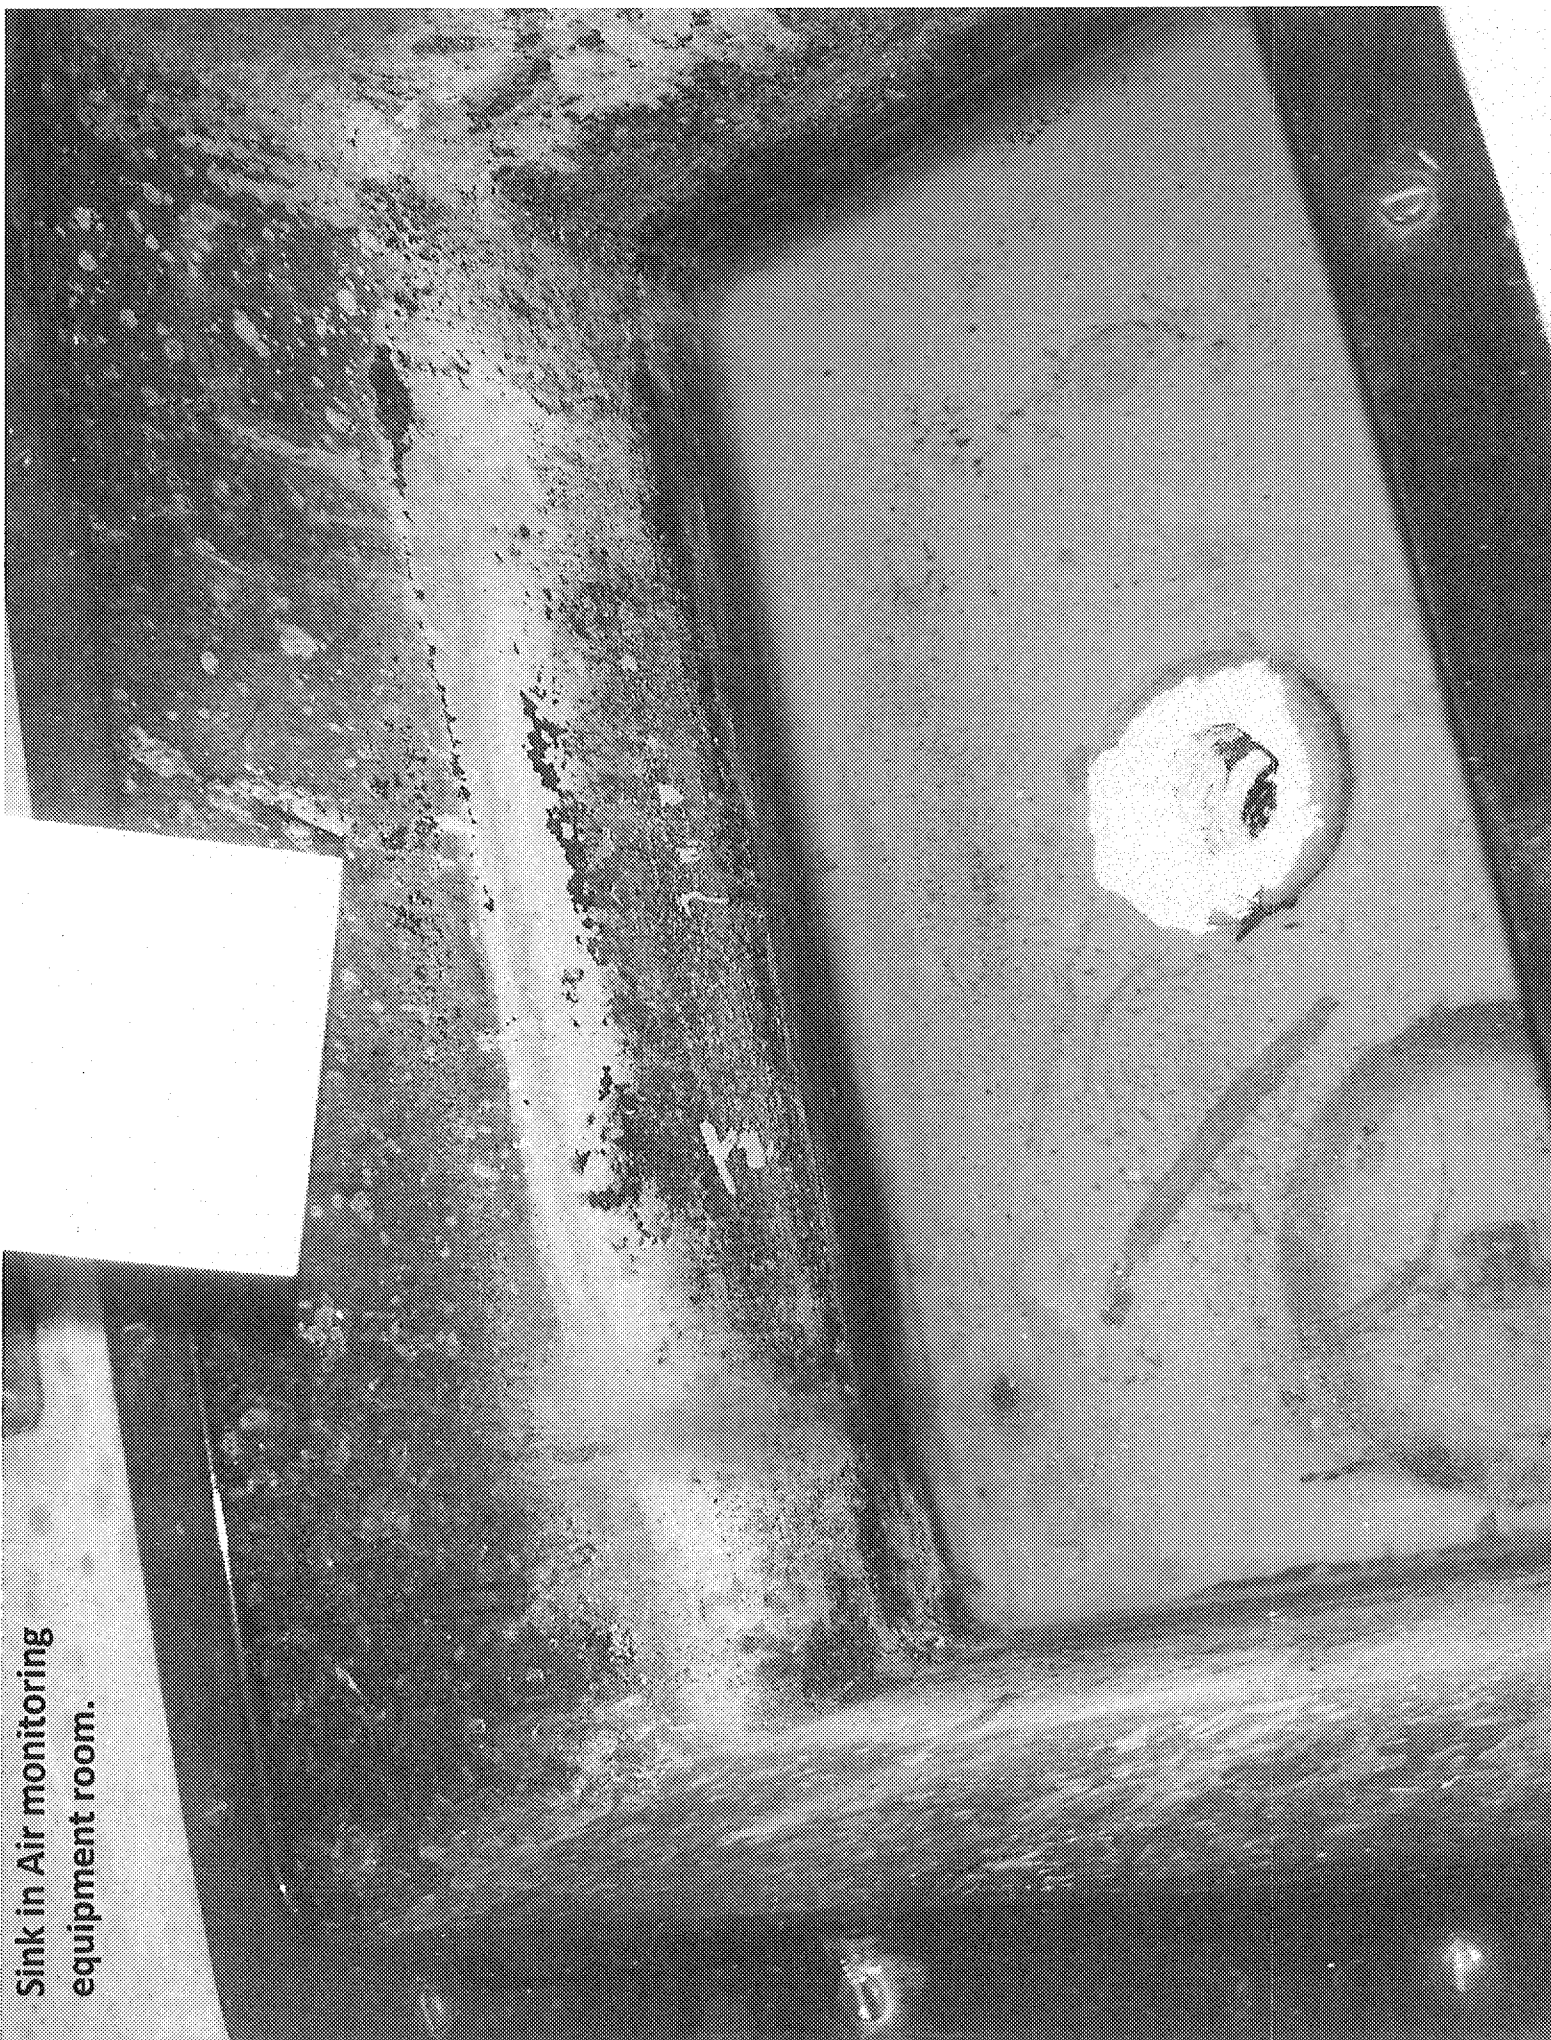
There is a sink in the primary room that has a note on it stating it has not been functional since October of 2007. This again reflects the neglected maintenance of the building. There is a toilet facility in the hallway smaller than most household closets with no sink to wash hands. Again there is evidence of leaks and disrepair. I would not even venture in to attempt to see if the toilet even flushed. There exists a lack of sanitary facilities for use by building occupants. There is also a concern that all of the chipping paint may contain lead and there is mold growth observed in various places. This raises the question of what may be hidden and what are the health ramifications of any molds and possibly any lead that may exist for occupants.

Sink in the air monitoring equipment room has been non-functioning since October 2007.

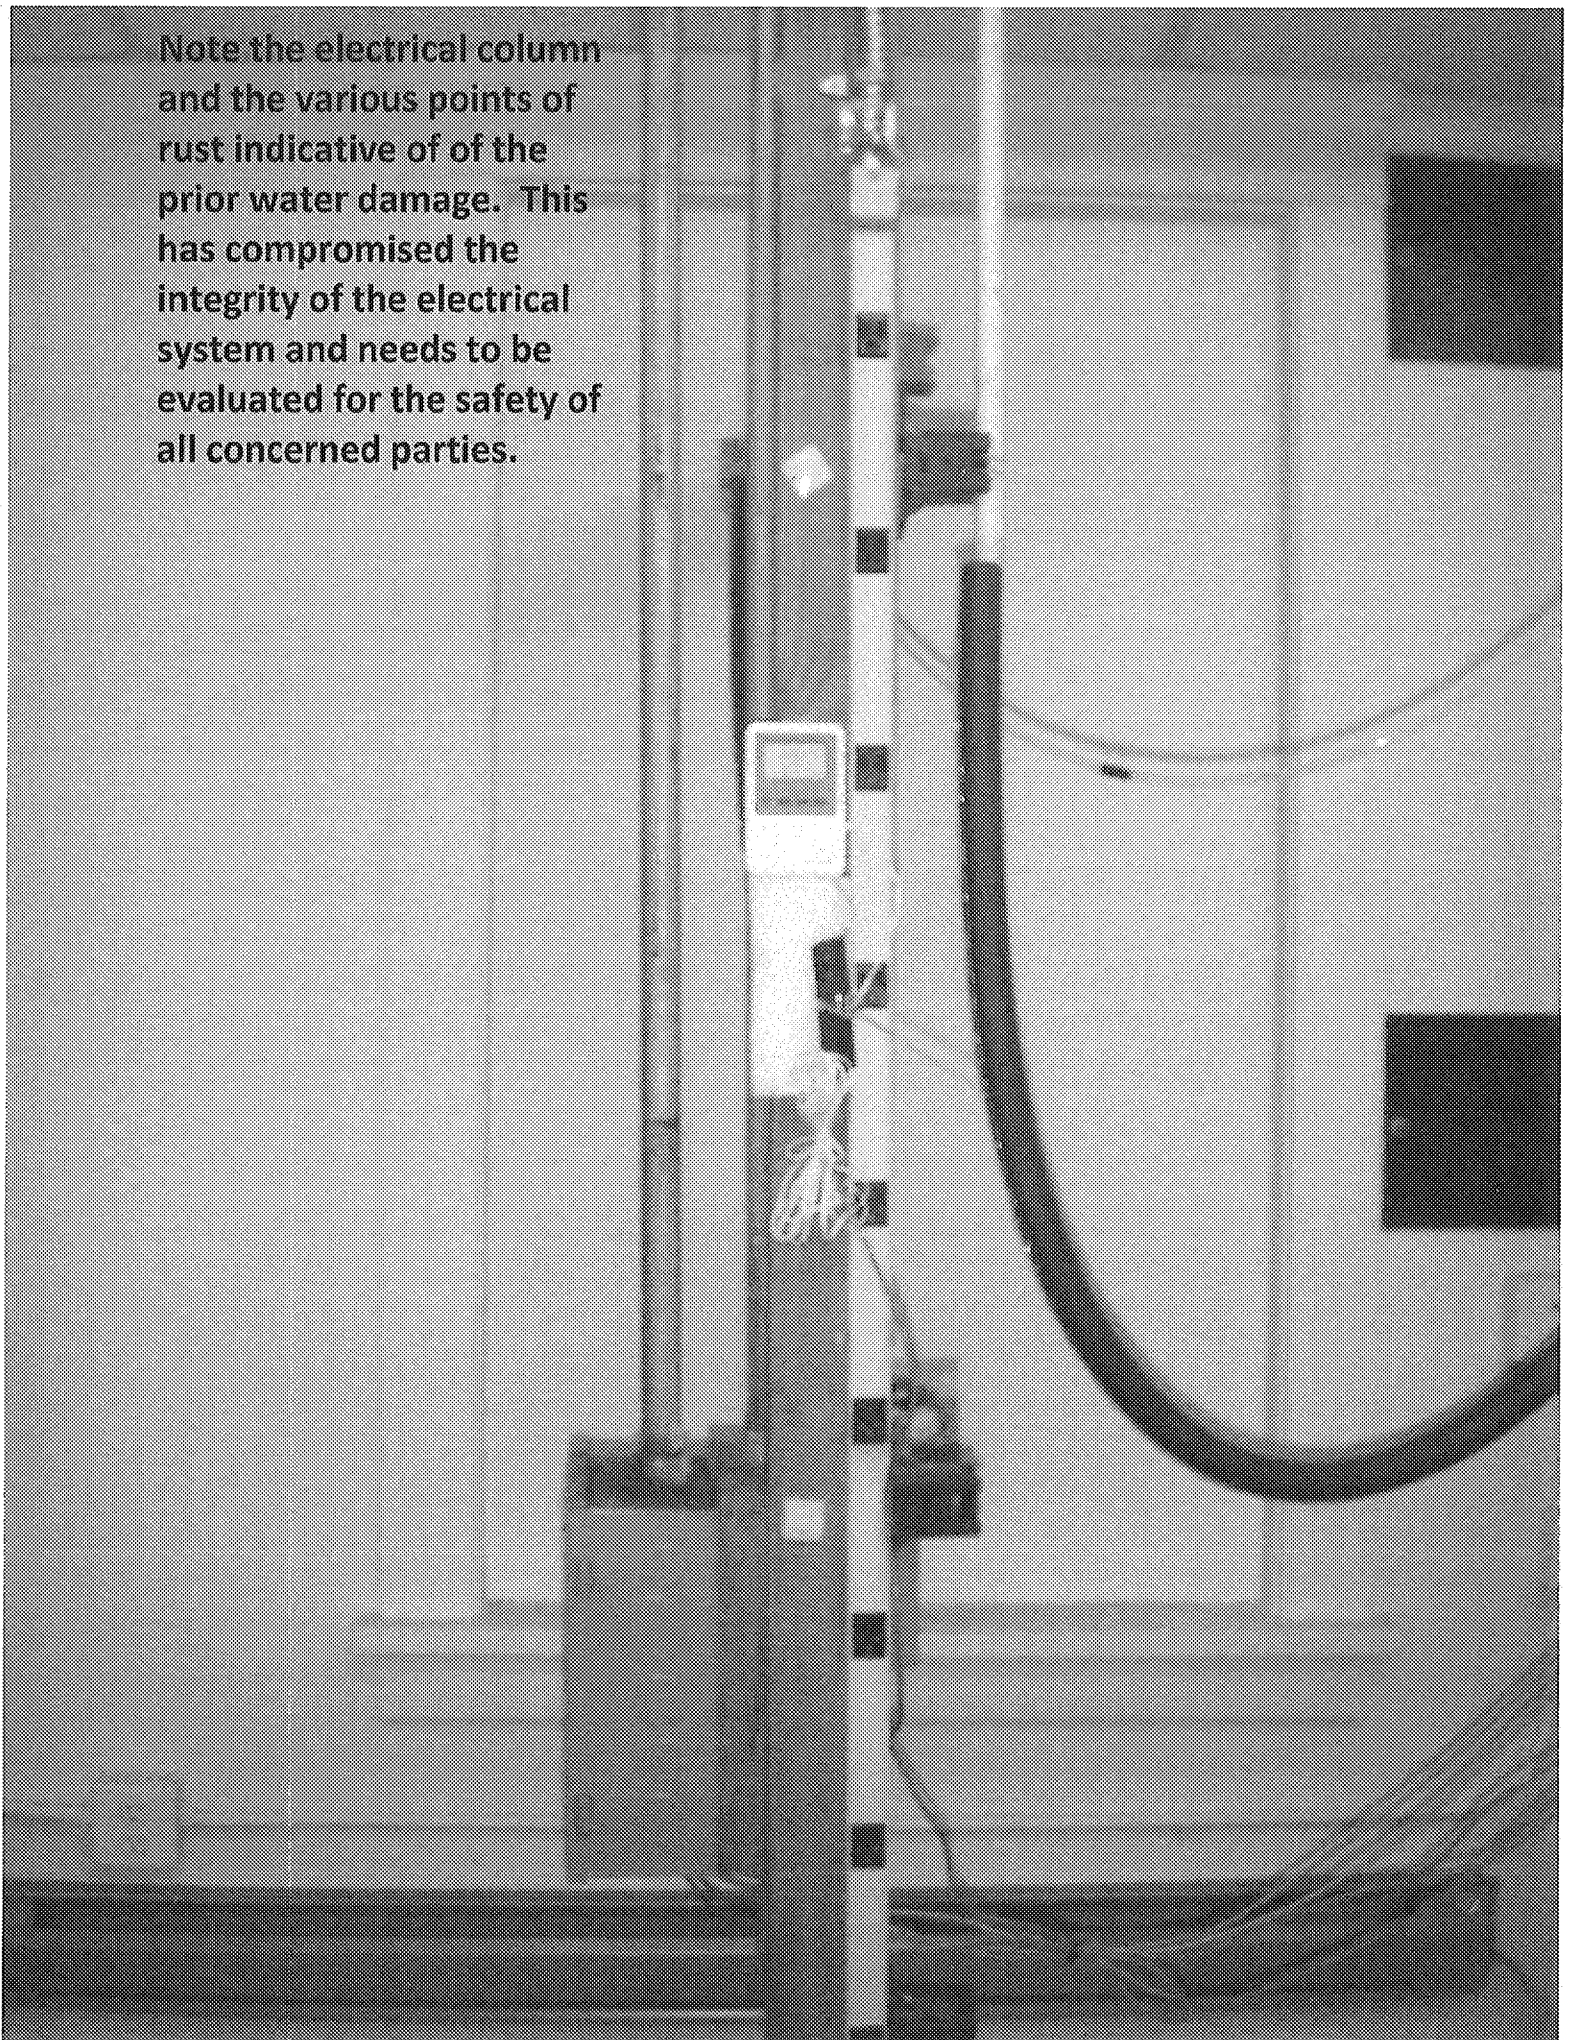
Note the electrical column and the various points of rust indicative of of the prior water damage. This has compromised the integrity of the electrical system and needs to be evaluated for the safety of all concerned parties.

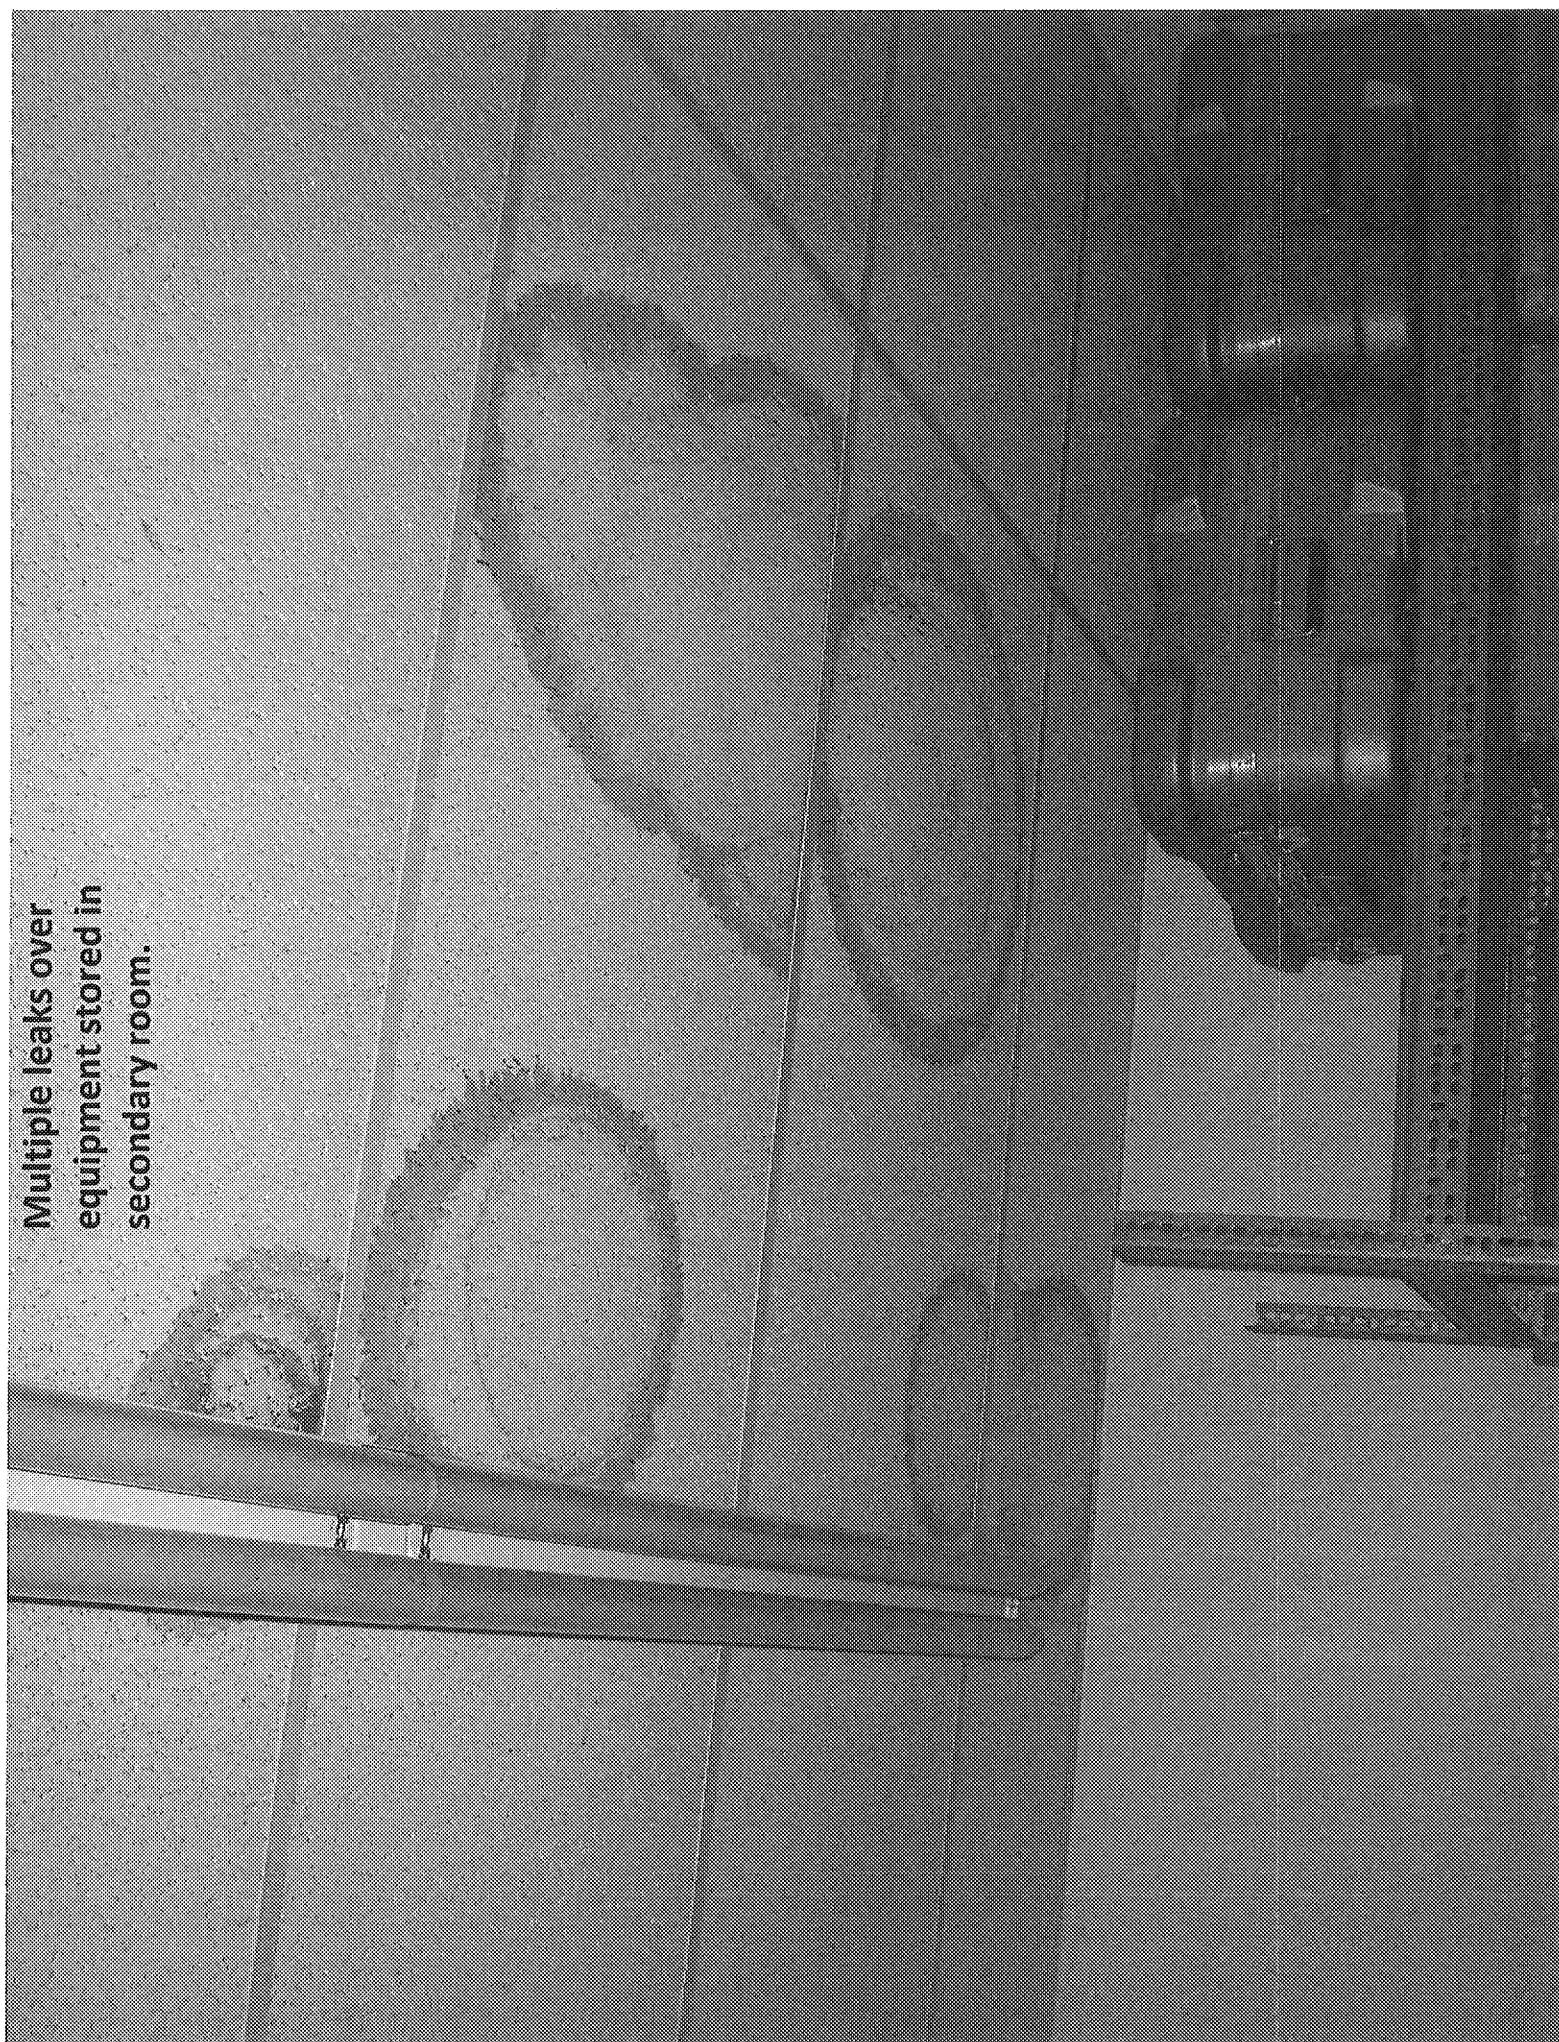
The secondary room again has multiple leaks in the ceiling with sagging tiles. There is a window which is the only method of gaining access to the roof where equipment is located. This means of access leaves our staff vulnerable to numerous injuries and possibly under adverse conditions a fatality.

Multiple leaks over
equipment stored in
secondary room.

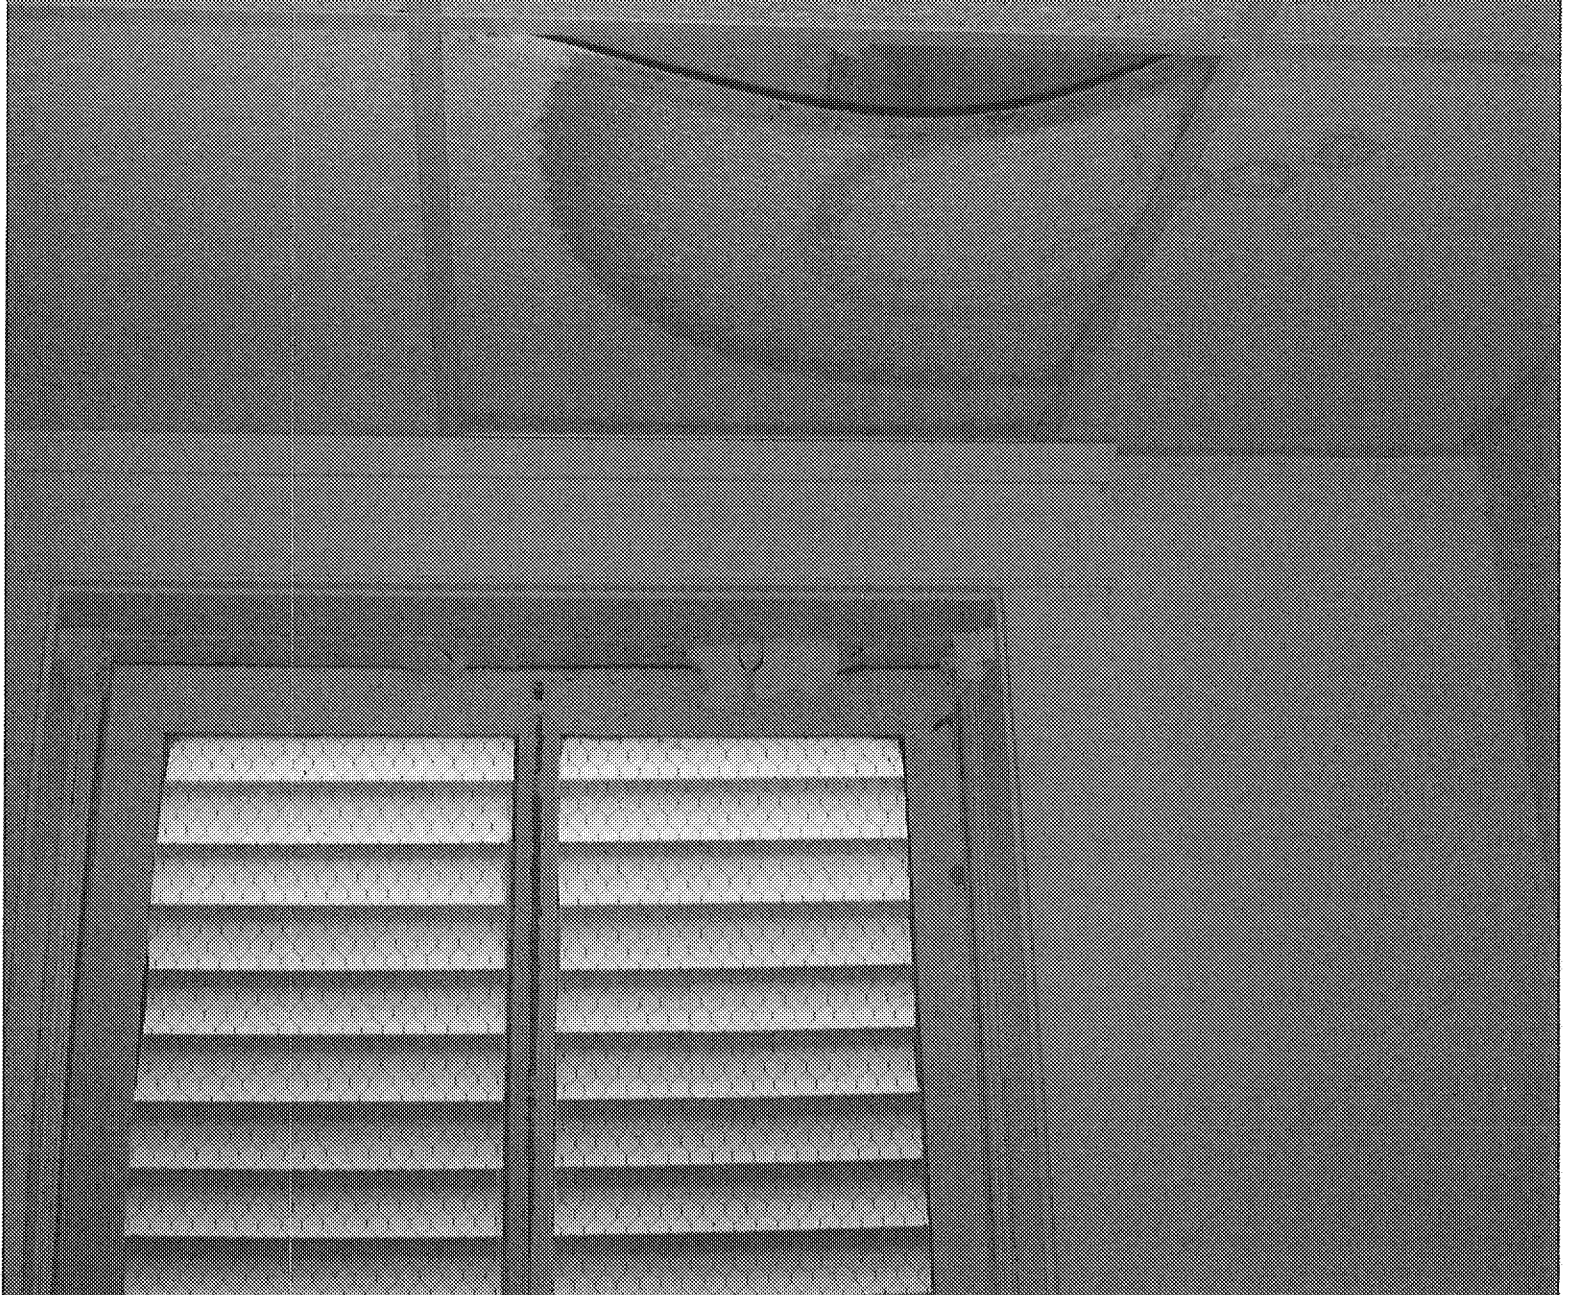
Leak over window in secondary room. Note: that the staff need to contort themselves to crawl out the window to access the rooftop and run the risk of slipping and injuring themselves in the process.

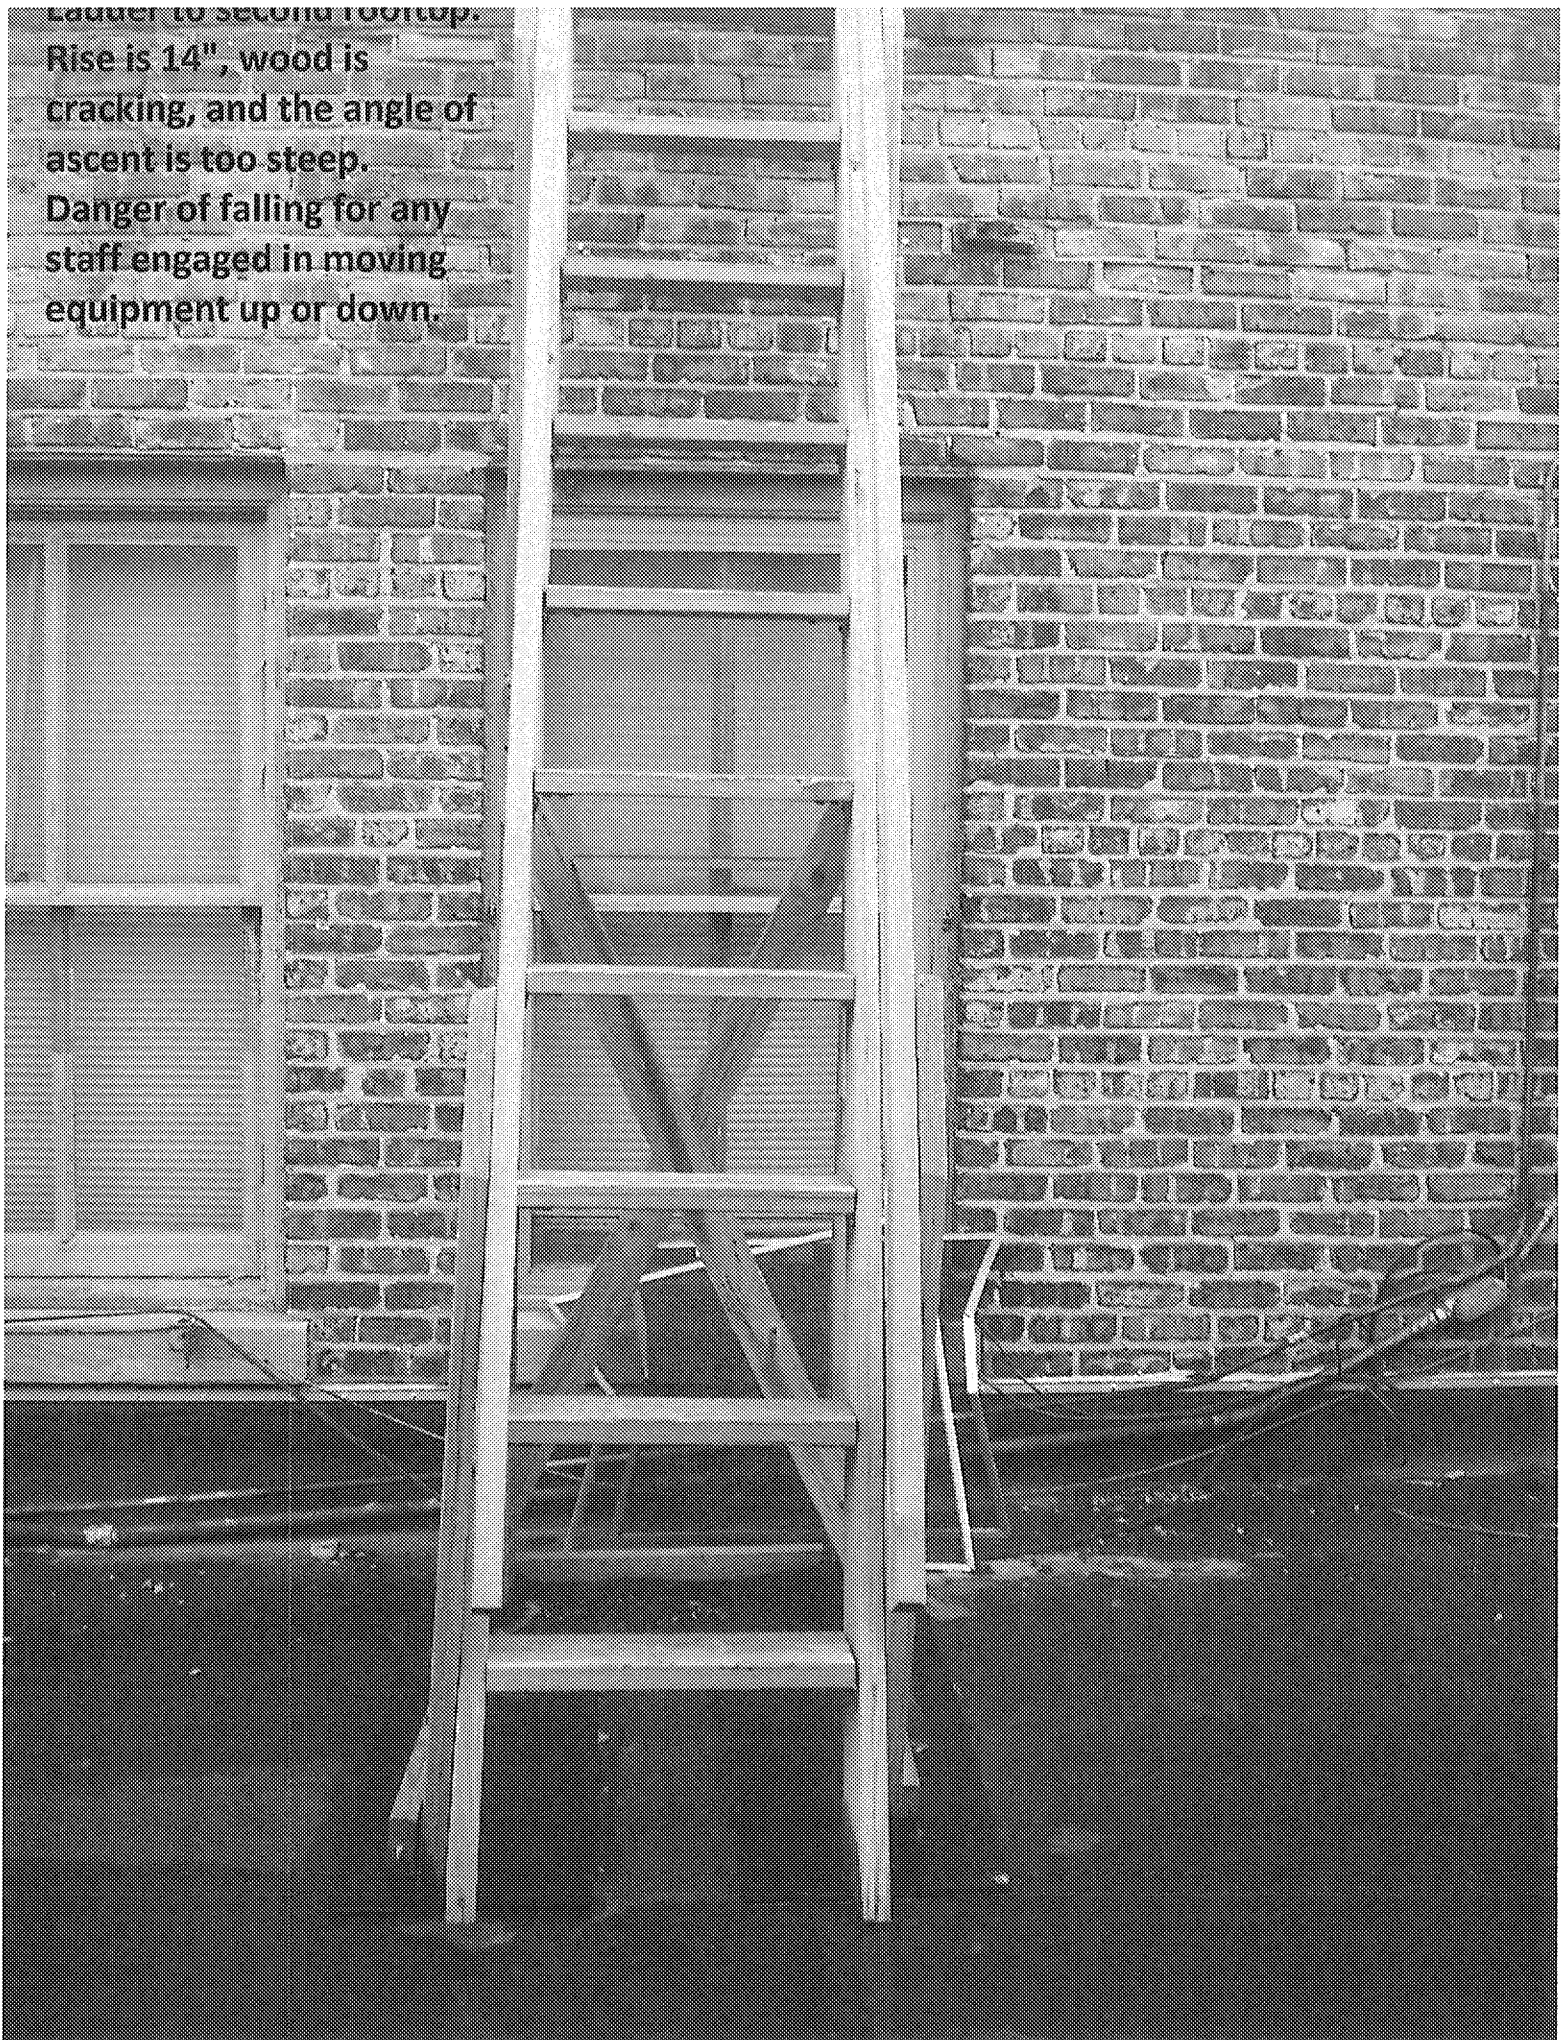
Ladder to second rooftop.

Once out on the roof the only means of access to a higher roof where the equipment is situated is a wooden stairway that besides not meeting current standards, is in a state of disrepair, extremely steep with a rise/run in the steps of $14/6^{1/2}$ inches, (standard rise/run is $7"/11"$). This is double the rise and nearly half the run, a recipe for tripping and falling from a height. The base of the stairway is not secured to the roof surface and it is not secured at the uppermost portion to the wall. There is no certification as to the load limits of the stairway. There is barely enough space to install a properly constructed access stairway. There is no fall protection at this point of access to the upper roof. There is nothing to guard against slippery surfaces on the stairway either.

Rise is 14", wood is cracking, and the angle of ascent is too steep.

Danger of falling for any staff engaged in moving equipment up or down.

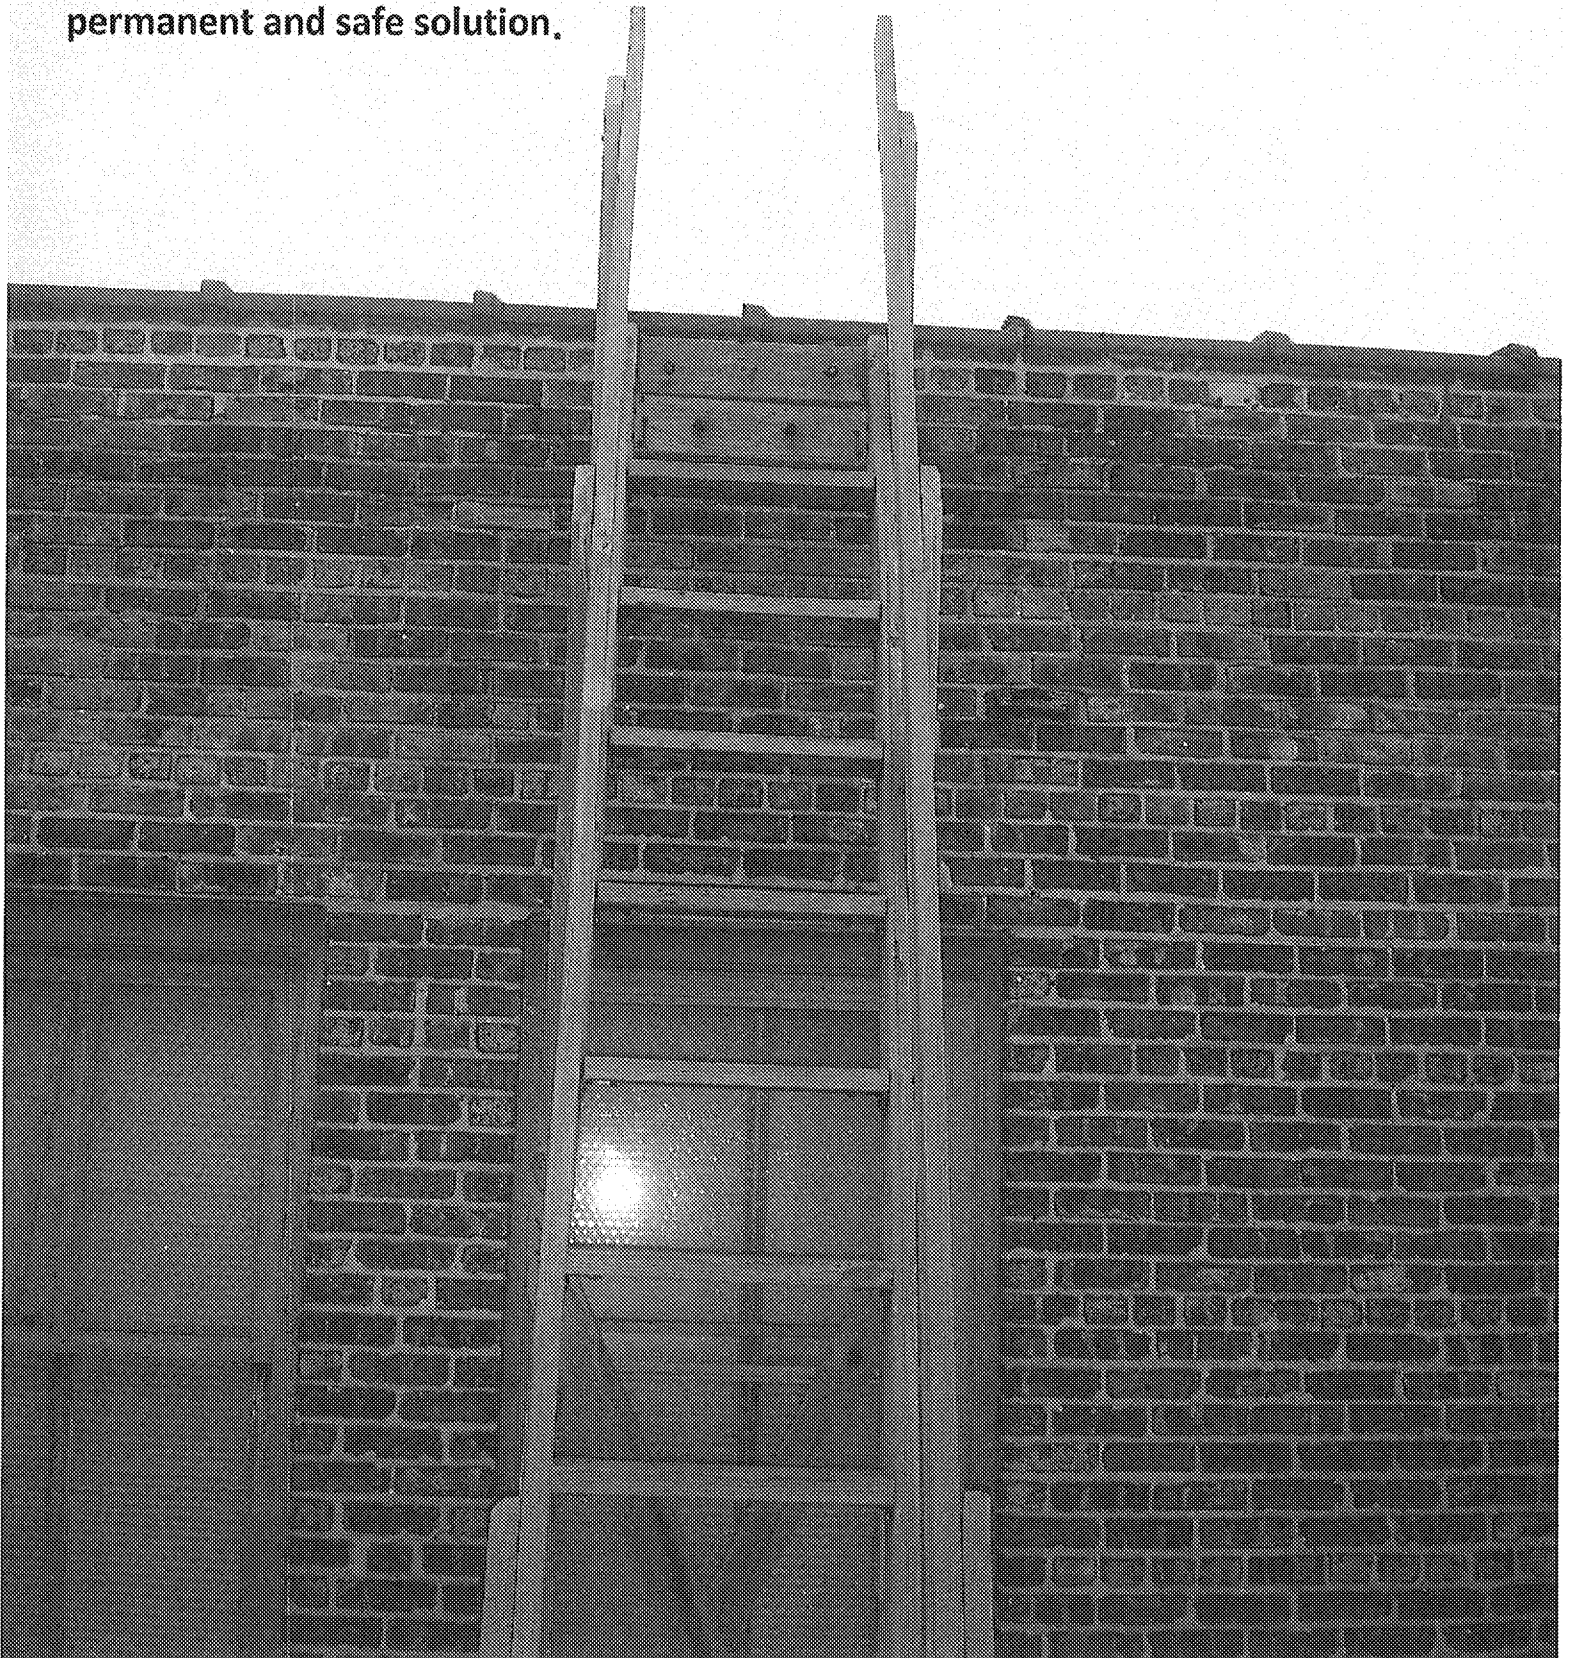
In addition to the other problems noted the ladder is not secured at the base nor at the top of the wall. There is no fall arrest system in place to protect staff members trying to ascend or descend this ladder. This situation demands a permanent and safe solution.
